RE: Report of Nuclear Roof Moisture Survey  
Orlando Public Library  
Roof Sections 2-3  
101 E. Central Boulevard  
Orlando, FL 32801

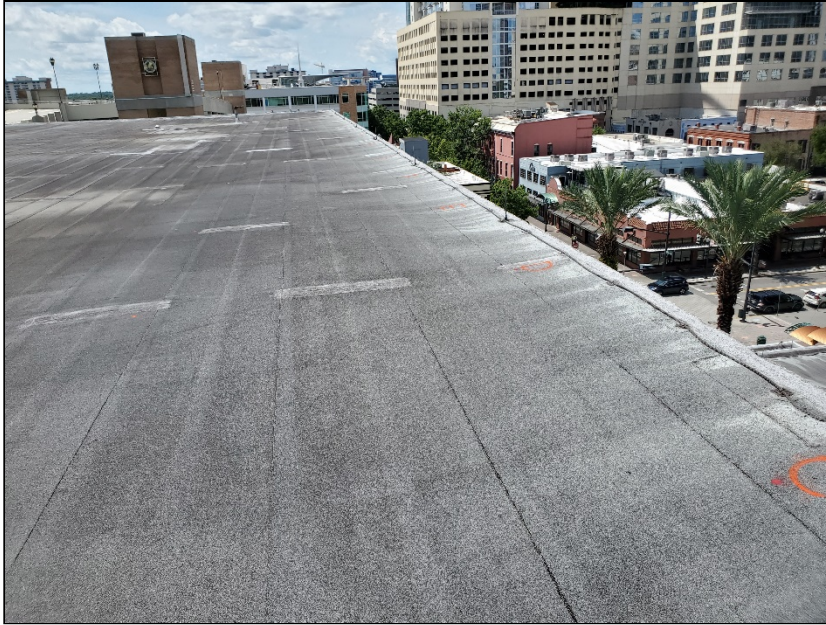
**Photo 1:** Overview of Roof Section 2.

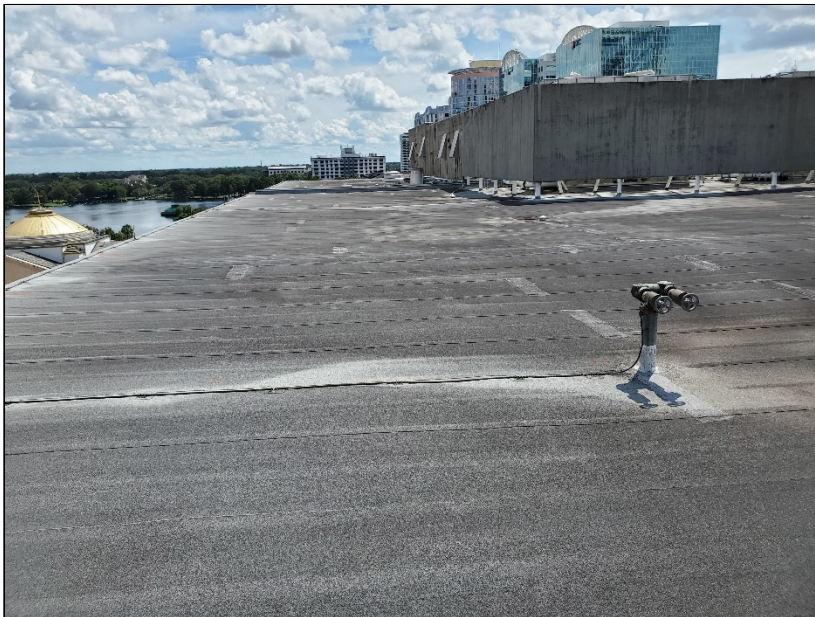
**Photo 2:** Overview of Roof Section 2.

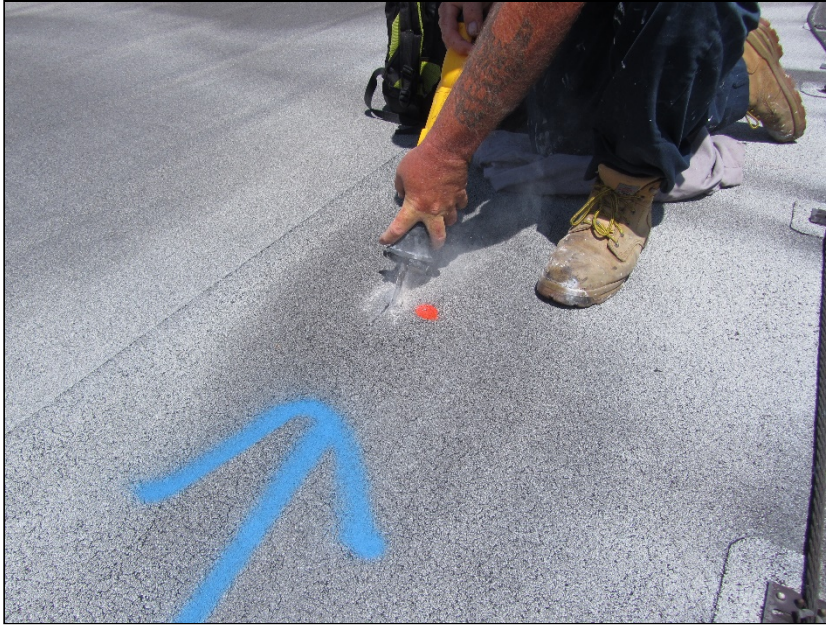
**Photo 3:** Roof Section 2 – Core Location N8 – Core in progress.

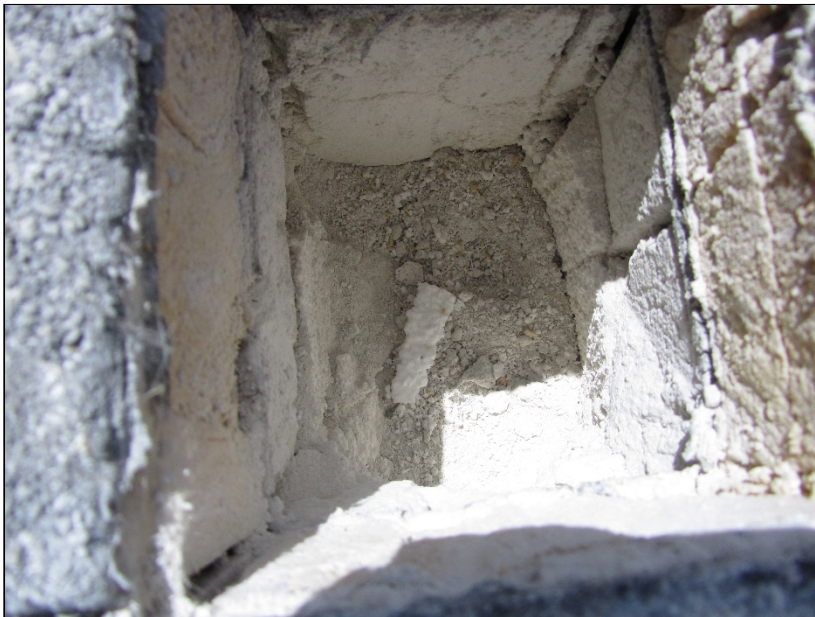
**Photo 4:** Roof Section 2 – Core Location N8 – roofing components relatively dry.

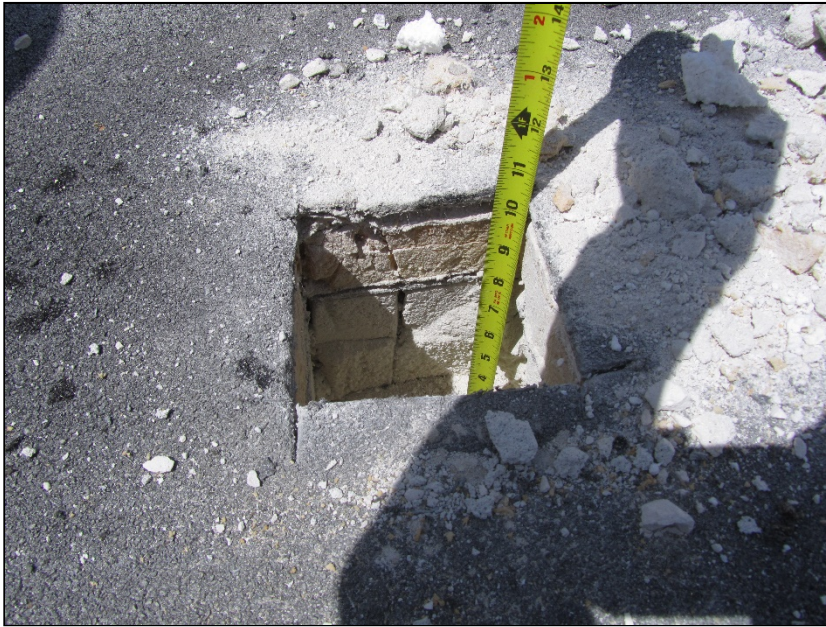
**Photo 5:** Roof Section 2 – Core Location N8 – Core thickness.

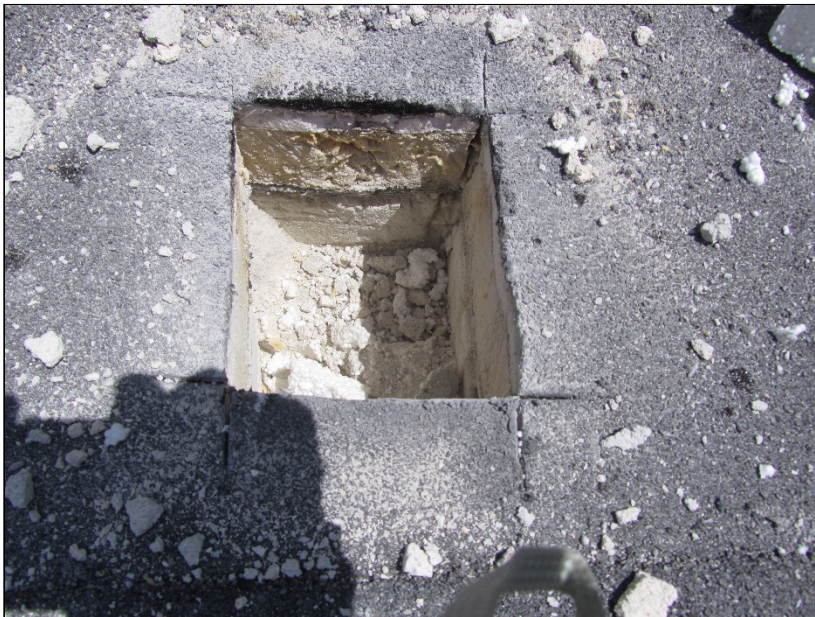
**Photo 6:** Roof Section 2 – Core Location C10 – relatively dry roofing components.

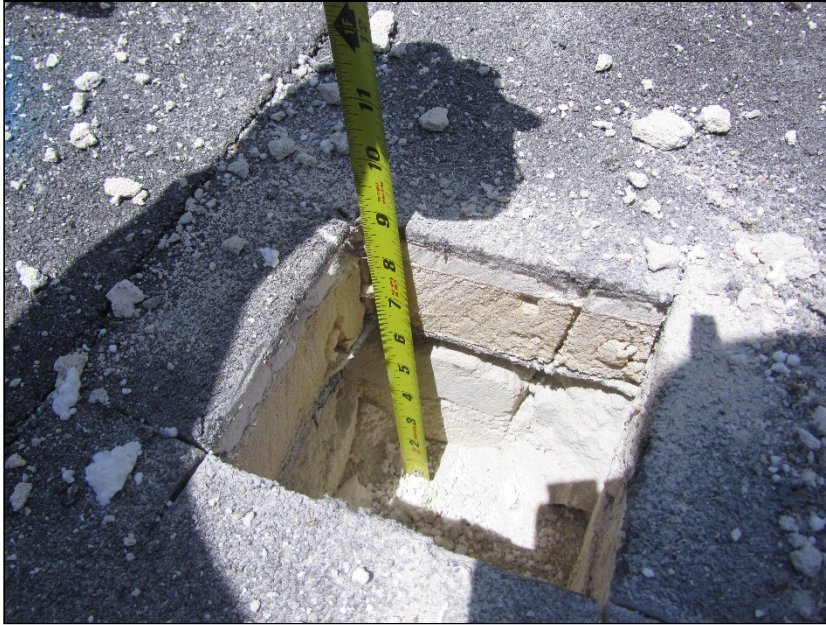
**Photo 7:** Roof Section 2 – Core Location C10 – Core thickness.

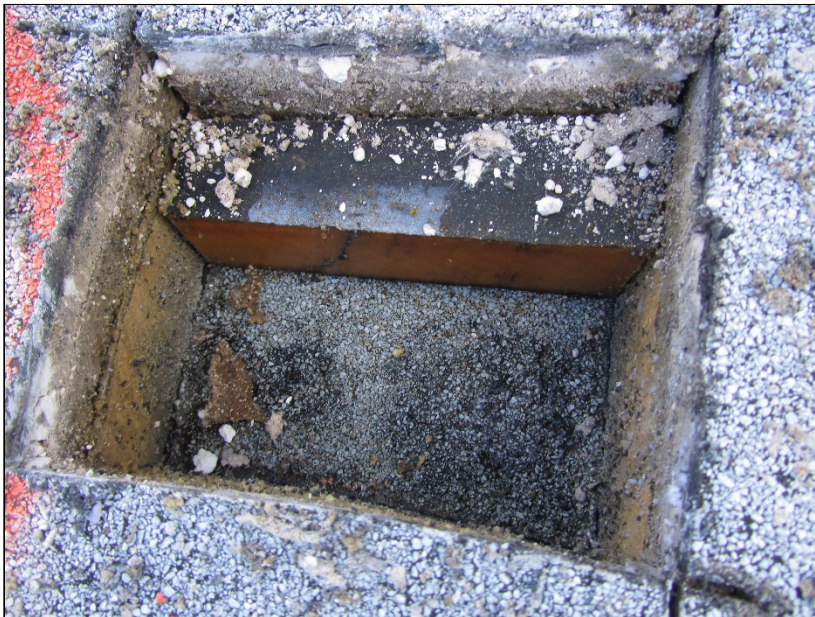
**Photo 8:** Roof Section 2 – Core Location A3 – moist roofing components.

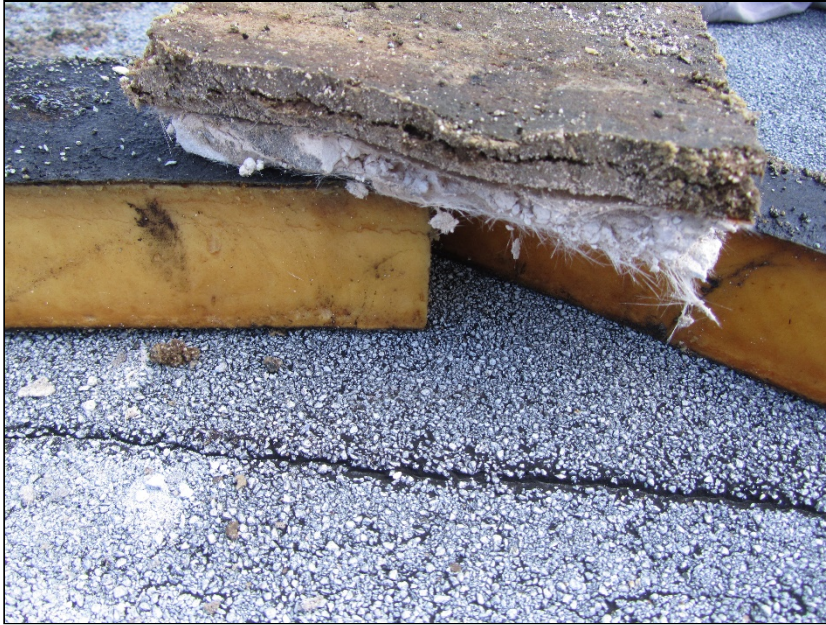
**Photo 9:** Roof Section 2 – Core Location A3 – insulation and cover boards moist.

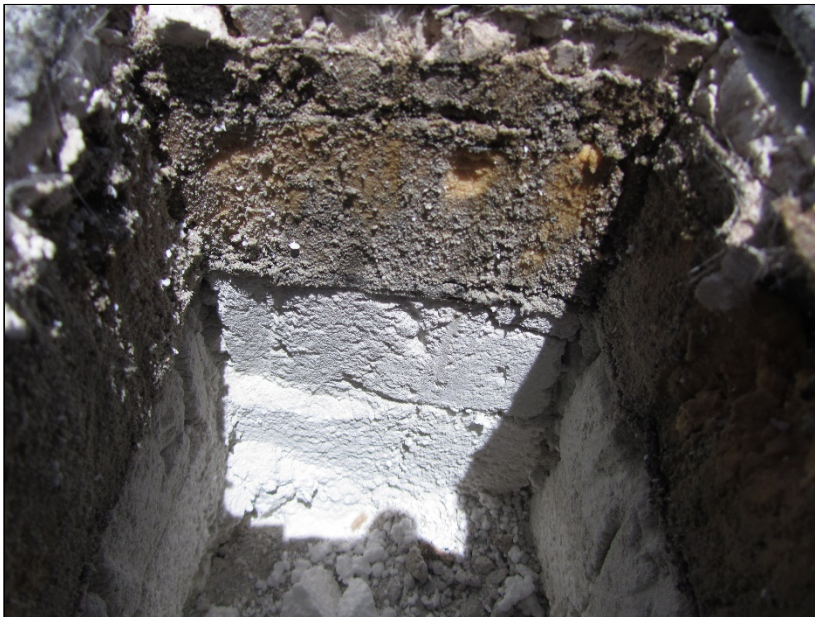
**Photo 10:** Roof Section 2 – Core Location A3 – View within core: note moist roofing components at insulation and cover board layers.

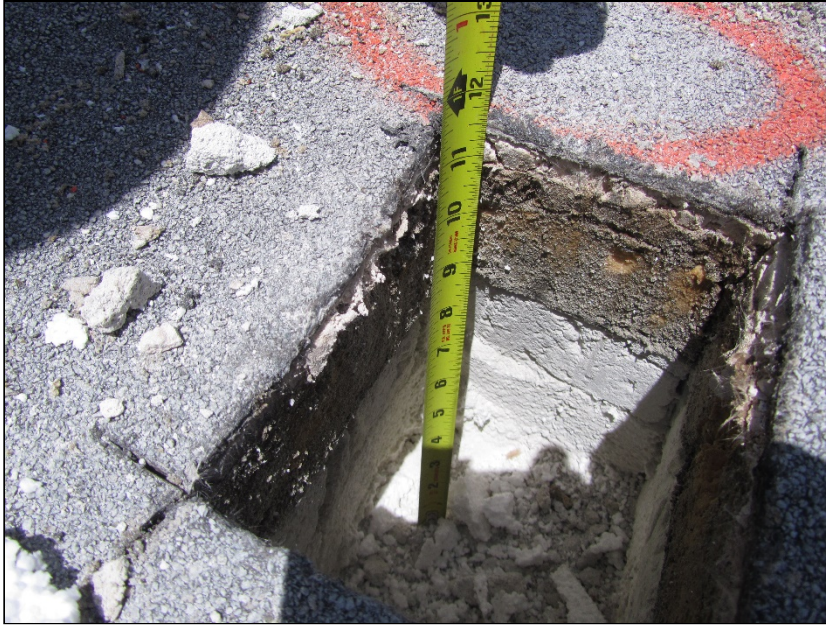
**Photo 11:** Roof Section 2 – Core Location A3 – Core thickness.

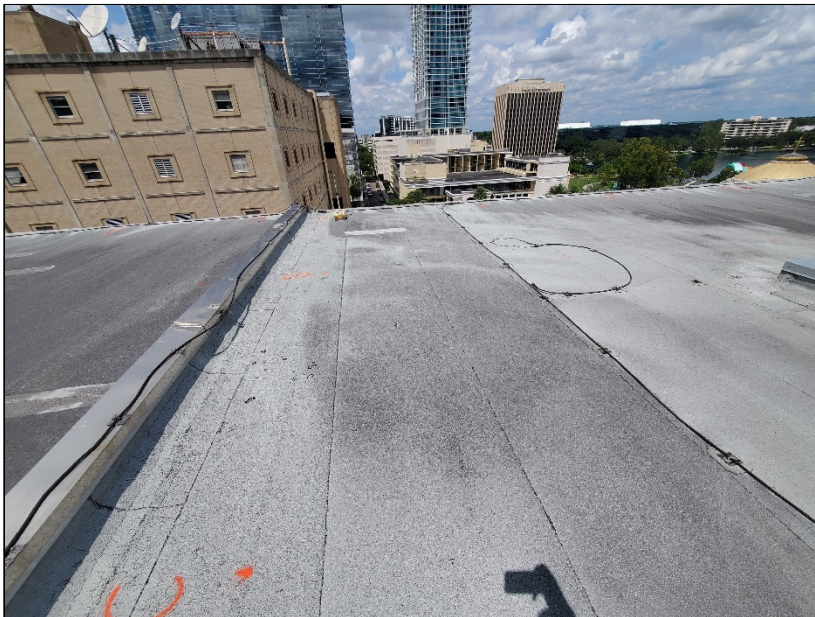
**Photo 12:** Overview of Roof Section 3.

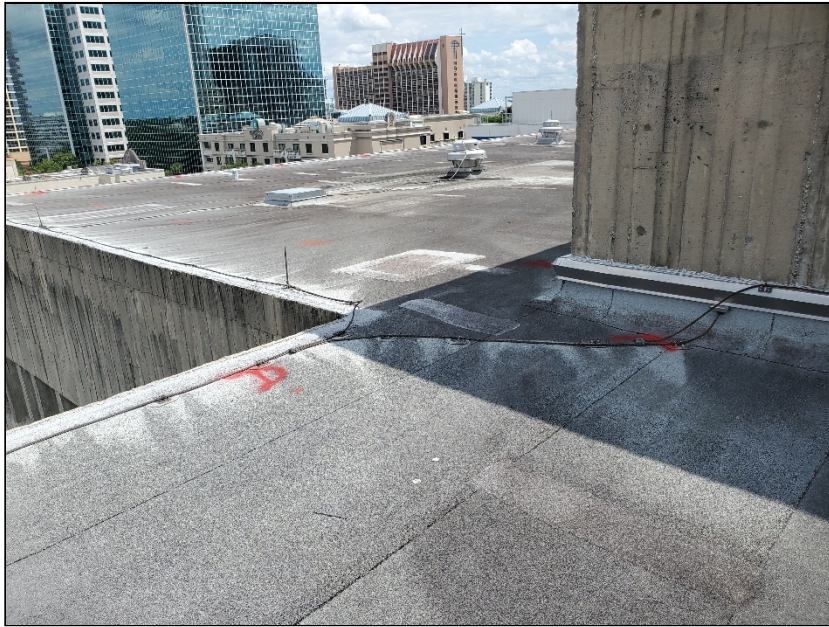
**Photo 13:** Overview of Roof Section 3.

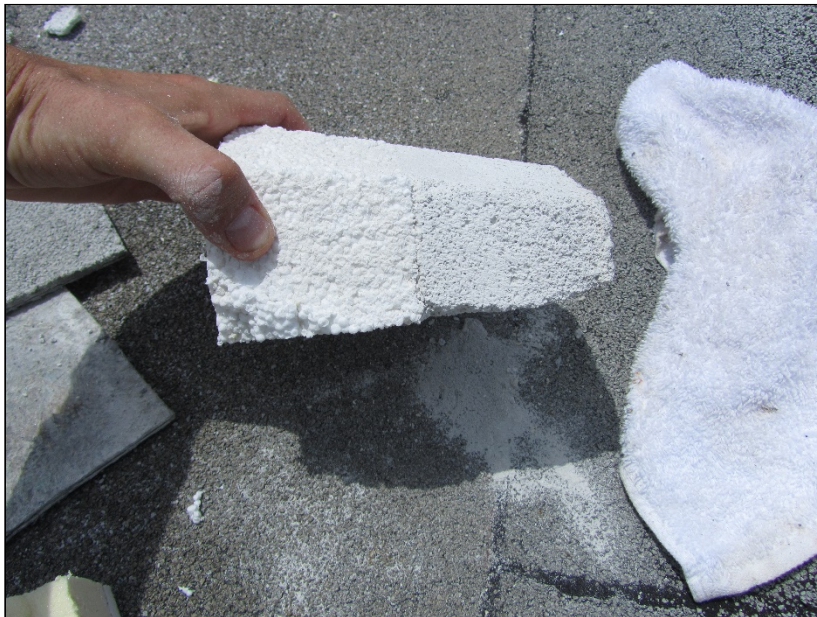
**Photo 14:** Roof Section 3 – Core Location F11 – relatively dry roofing components.

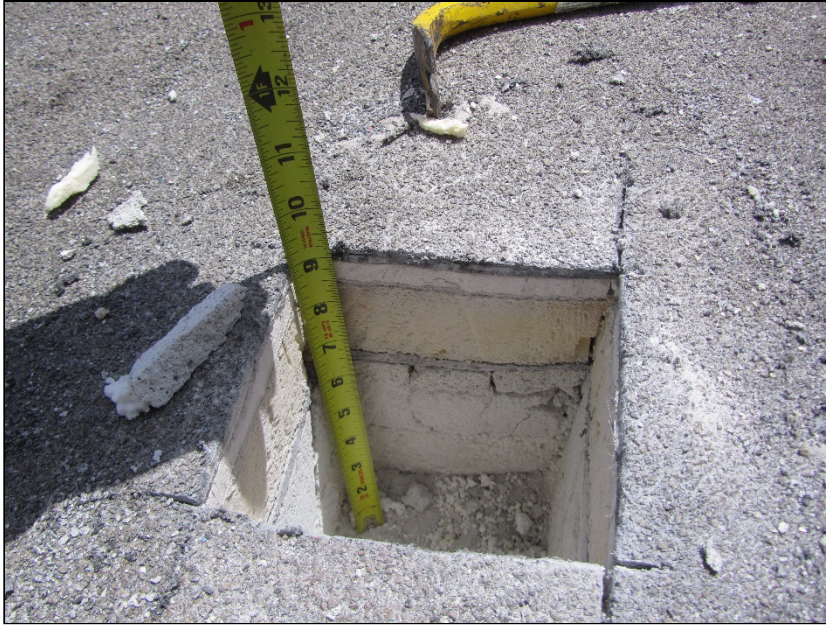
**Photo 15:** Roof Section 3 – Core Location F11 – core thickness.

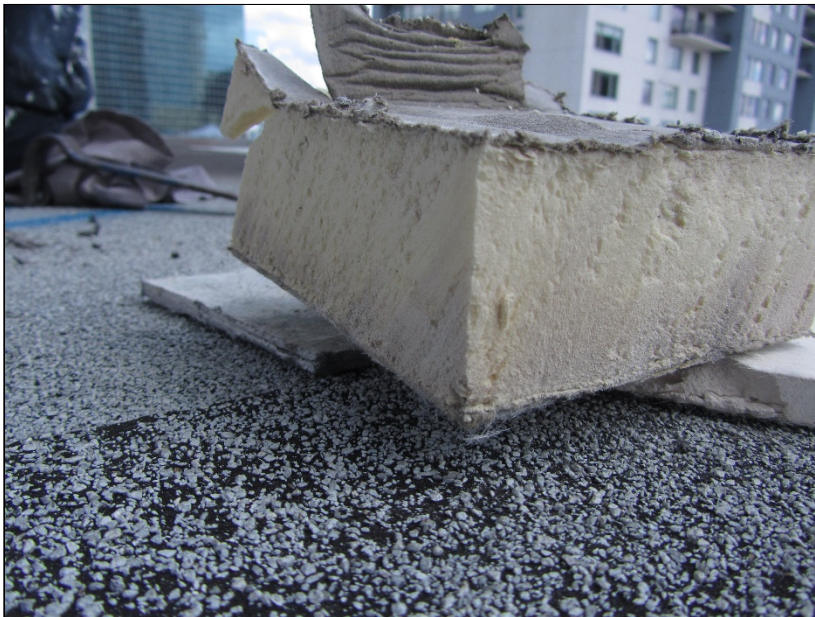
**Photo 16:** Roof Section 3 – Core Location L2 – polyiso insulation layer relatively dry.

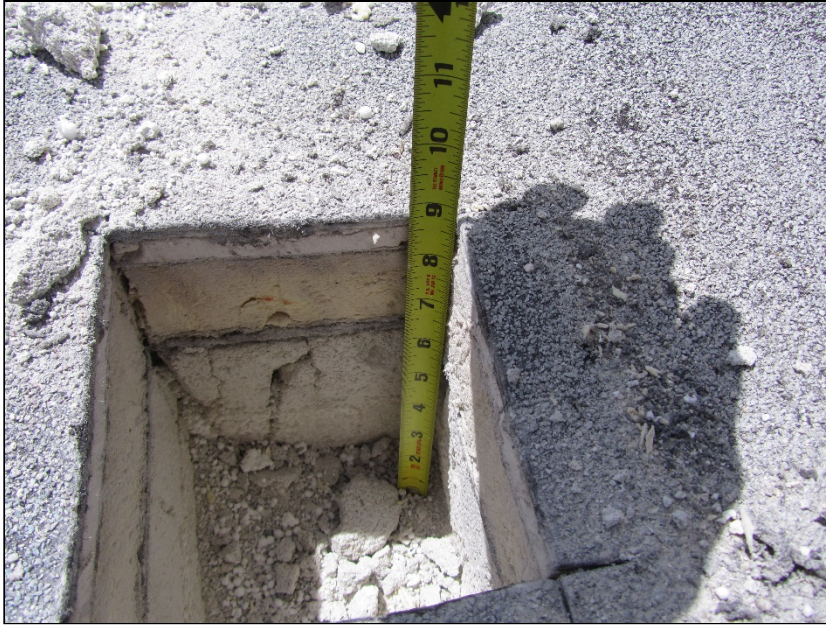
**Photo 17:** Roof Section 3 – Core Location L2 – core thickness.

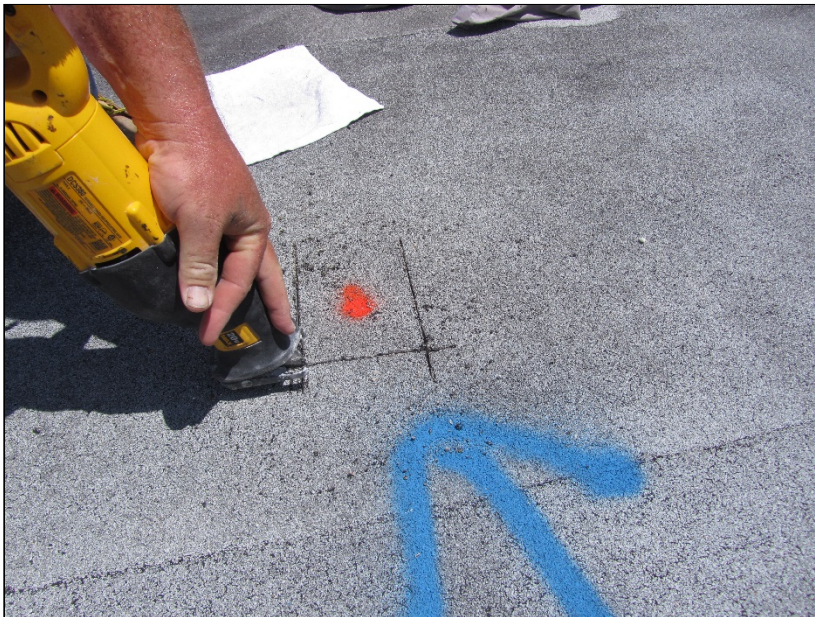
**Photo 18:** Roof Section 3 – Core Location B3 – coring in progress.

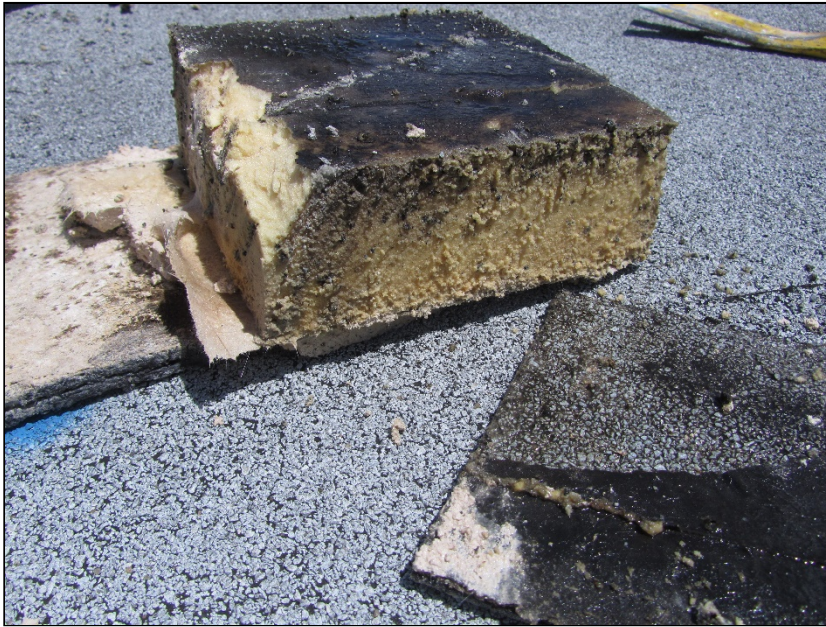
**Photo 19:** Roof Section 3 – Core Location B3 – moist conditions at insulation board.

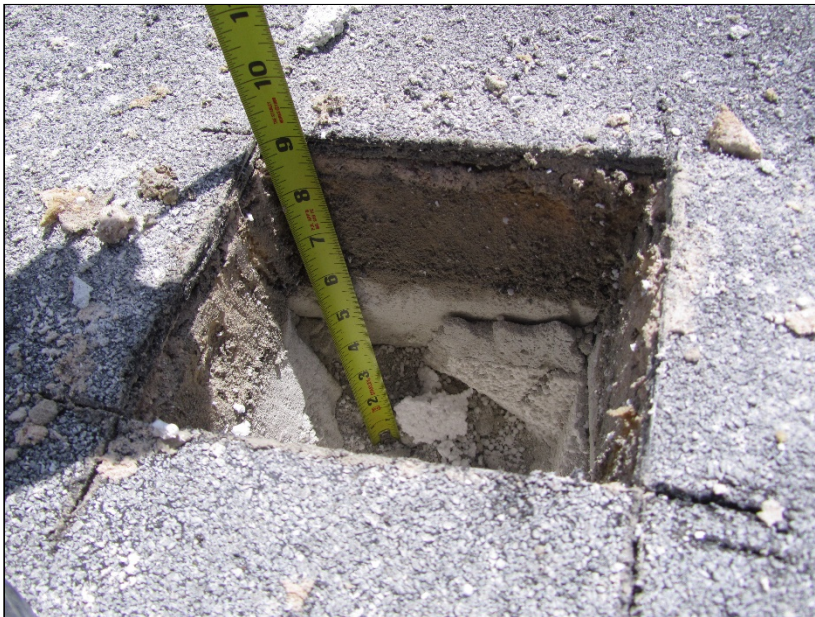
**Photo 20:** Roof Section 3 – Core Location B3 – core thickness. Note moist conditions within core at insulation and cover board layers.
