RE: Report of Nuclear Roof Moisture Survey
Orlando Public Library
Roof Sections 4-11
101 E. Central Boulevard
Orlando, FL 32801

In general accordance with your request and your authorization of our proposal (Number 273623R0 dated June 15, 2022 and authorized August 9, 2022), Intertek is pleased to submit the following roof nuclear moisture survey report for the above-referenced property. Included in this report is an outline of the project information, performed scope of services, results and conclusions.

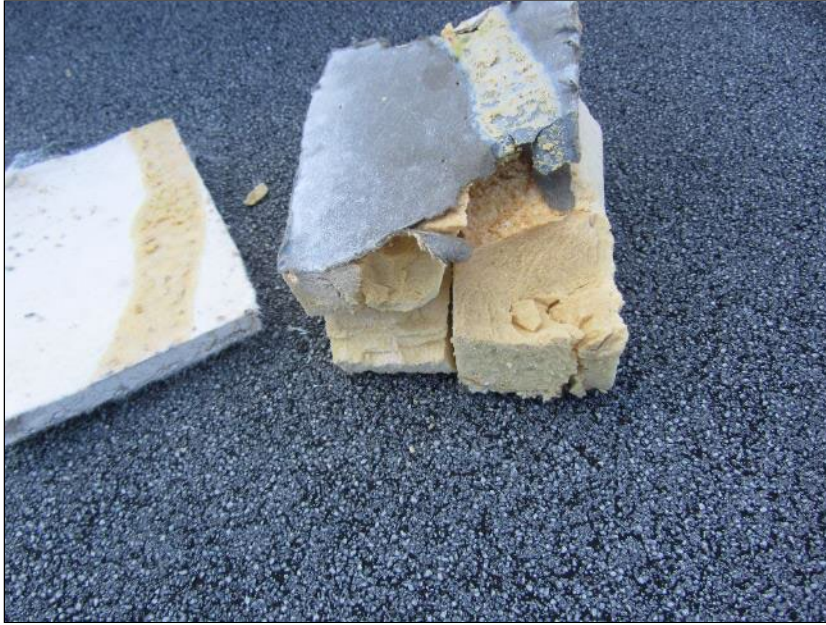
Photo 1: Roof Section 4 – Core Location J7.

Core Location / Nuke Reading	Core Thickness	Observation
Roof Section 4 J7/ 5	9"	Roof components relatively dry
Roof Section 4 B2 / 7	9.75"	Roof components relatively dry
Roof Section 4 G4/ 10	5.75"	Roof components relatively dry
Roof Section 5 E11/ 5	10"	Roof components relatively dry
Roof Section 5 E2/ 7	10.5"	Roof components relatively dry
Roof Section 5 D6/ 11	6"	Roof components relatively dry
Roof Section 6 N3/ 5	13.5"	Roof components relatively dry
Roof Section 6 AE10/ 9	10"	Roof components relatively dry
Roof Section 6 C10/ 21	9"	Moist cover and insulation boards
Roof Section 6A A5/ 6	10.75"	Roof components relatively dry
Roof Section 6A B13/ 8	9.5"	Roof components relatively dry
Roof Section 6A B19 / 10	9.75"	Insulation board facer stained
Roof Section 7/8 G2 / 8	8"	Roof components relatively dry
Roof Section 7/8 H15 / 12	9"	Moist LWIC
Roof Section 7/8 F10/ 16	6.25"	Moist insulation board and LWIC

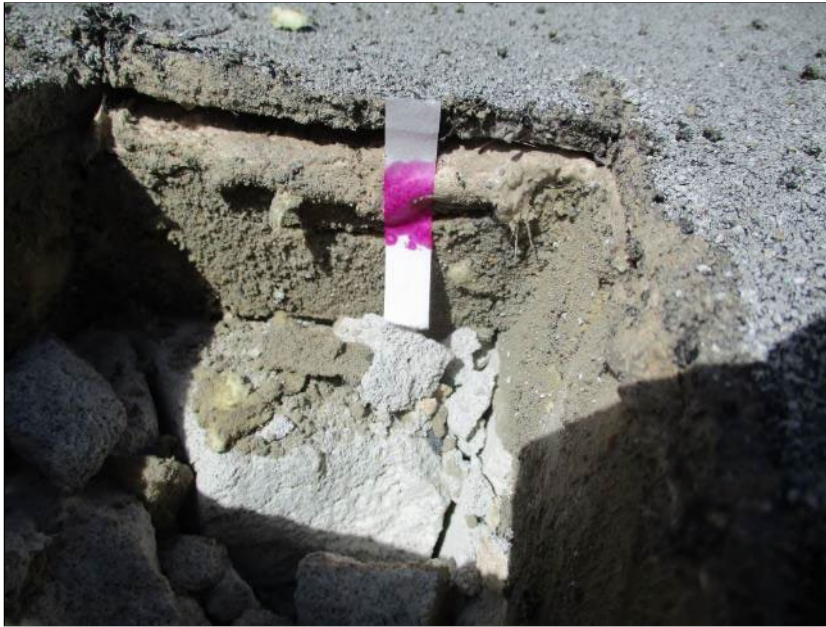
Photo 17: Roof Section 6 – Core Location C10. Red coloring on litmus paper indicative of the presence of moisture.

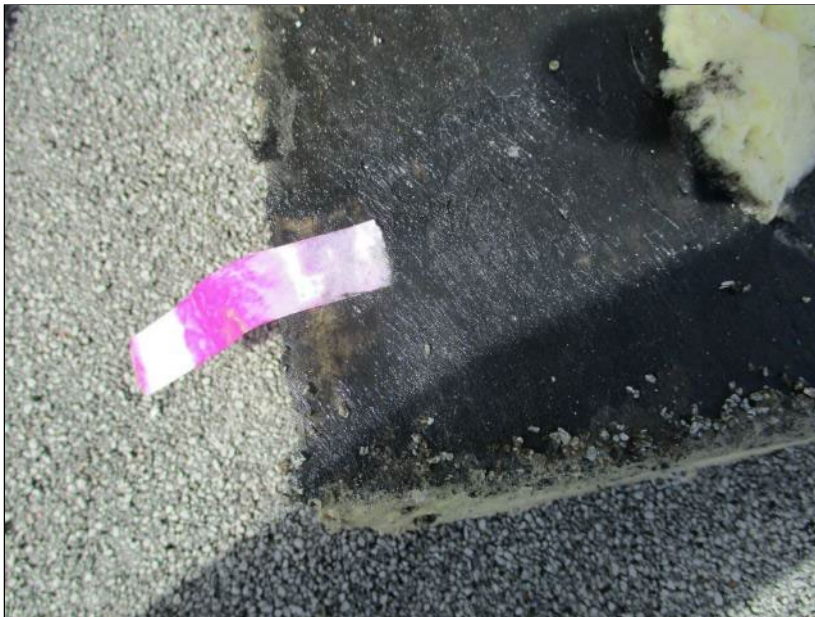
Photo 18: Roof Section 6 – Core Location C10. Red coloring on litmus paper indicative of the presence of moisture.

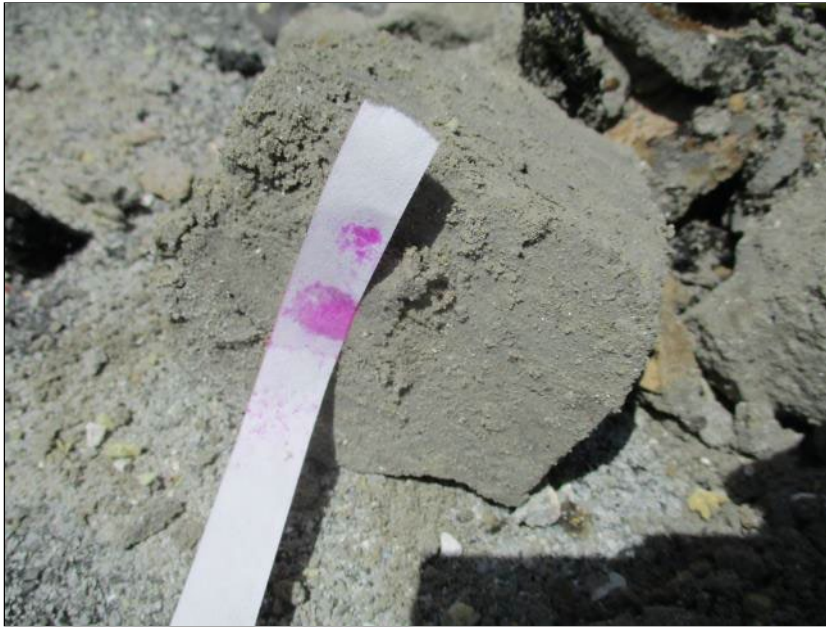
Roof Section 9 B16 / 13	4"	Roof components relatively dry
Roof Section 9 C6/ 24	3"	Moist EPS foam and LWIC
Roof Section 9 B3 / 30	3.5"	Moist EPS foam and LWIC
Roof Section 10 Q5/ 7	9"	Roof components relatively dry
Roof Section 10 G4 / 13	6.25"	Slightly moist LWIC
Roof Section 10 E3 / 16	7"	Moist insulation board and LWIC
Roof Section 11 B9/ 7	6.75"	Roof components relatively dry
Roof Section 11 J2/ 10	5.5"	Roof components relatively dry – bottom of EPS foam was discolored
Roof Section 11 E7/ 18	2.75"	Mostly dry with slightly humid LWIC with discoloration

Photo 59: Roof Section 10 – Core Location E3. Red coloring on litmus paper indicative of the presence of moisture.

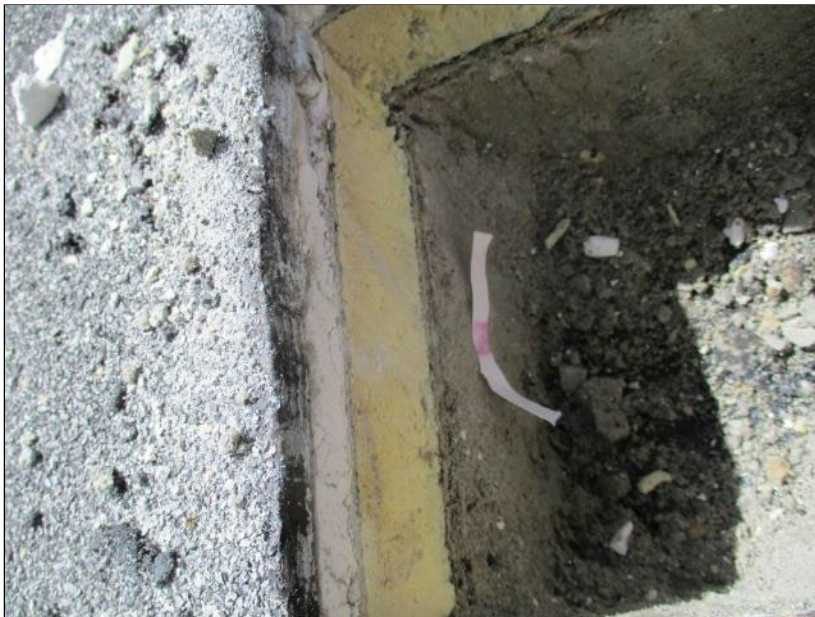
Photo 60: Roof Section 10 – Core Location E3. Red coloring on litmus paper indicative of the presence of moisture.
