RE: Report of Nuclear Roof Moisture Survey
Orlando Public Library
Roof Sections 4-11
101 E. Central Boulevard
Orlando, FL 32801

In general accordance with your request and your authorization of our proposal (Number 273623R0 dated June 15, 2022 and authorized August 9, 2022), Intertek is pleased to submit the following roof nuclear moisture survey report for the above-referenced property. Included in this report is an outline of the project information, performed scope of services, results and conclusions.

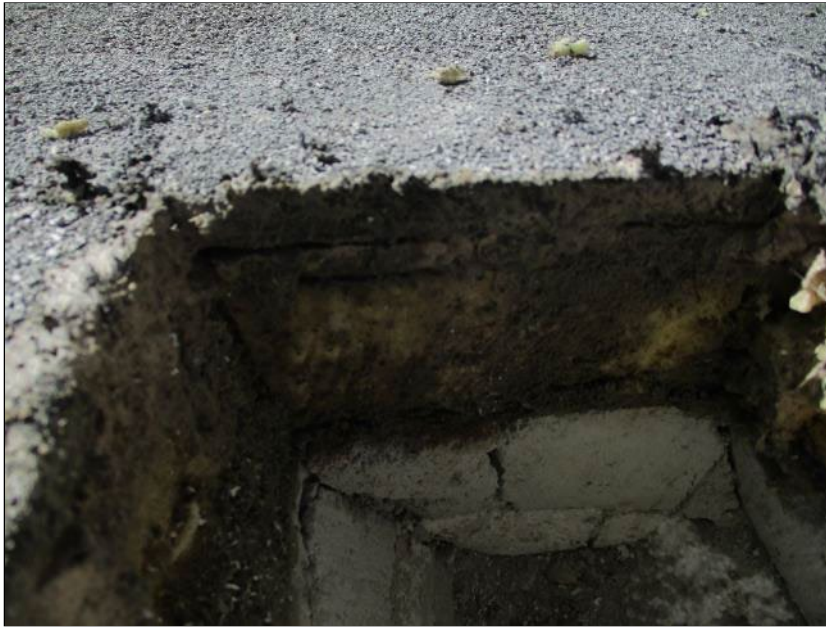
Photo 18: Roof Section 6 – Core Location C10. Red coloring on litmus paper indicative of the presence of moisture.

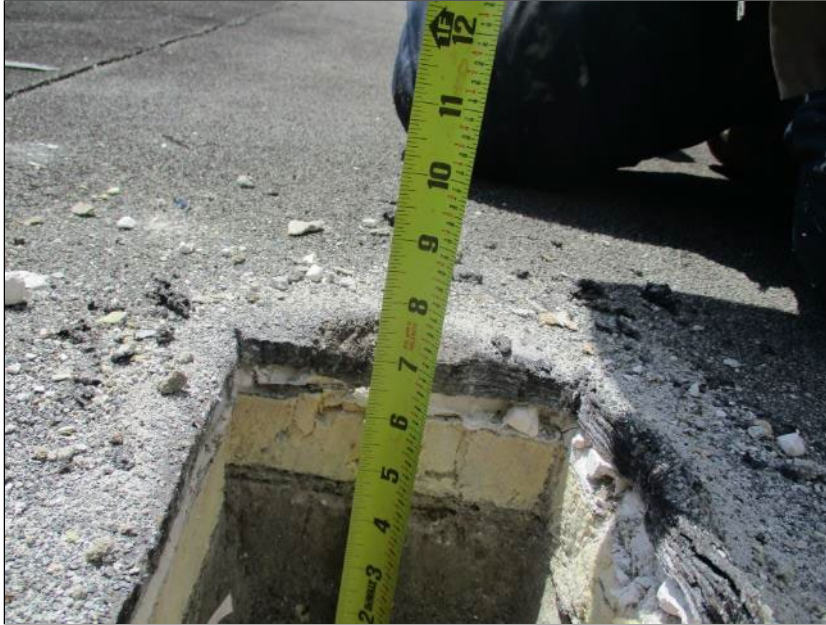
Photo 60: Roof Section 10 – Core Location E3. Red coloring on litmus paper indicative of the presence of moisture.

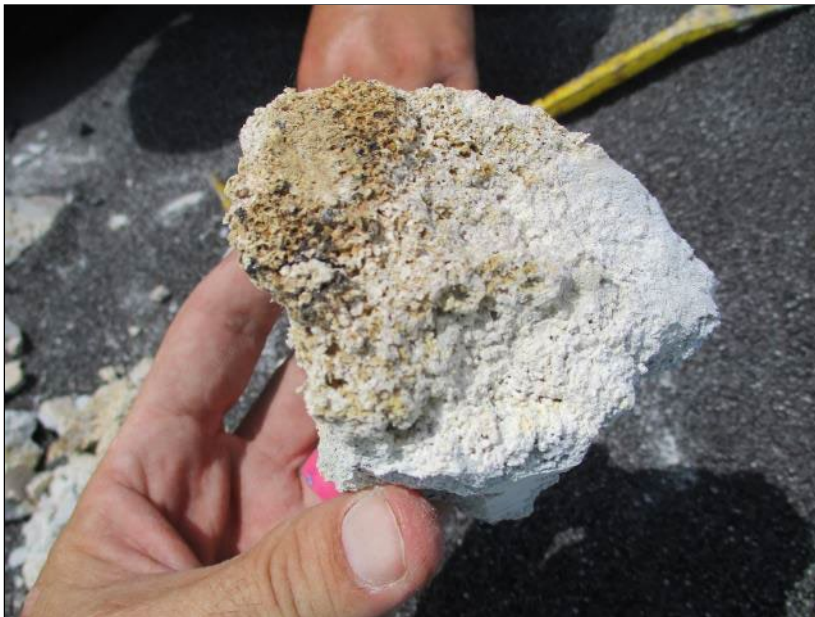
Photo 68: Roof Section 11 – Core Location E7.

ROOF 11 LOC E7 HIGH18	ASPHALT	187.51	313.76	313.05	126.25	125.54	0.71	0.6%
	LWICONCRETE	90.3	425.35	307.2	335.05	216.9	118.15	54.5%

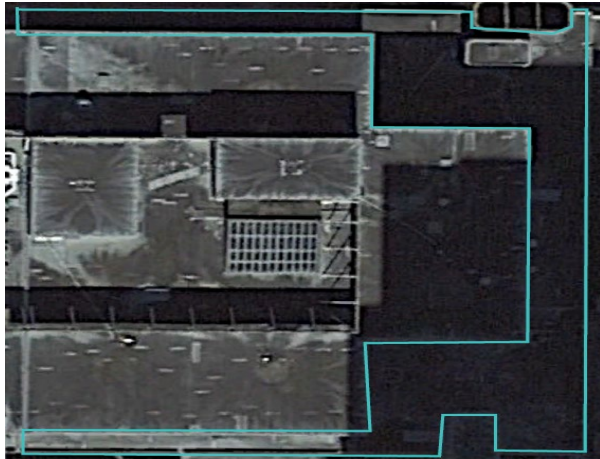
FIGURE 1
MOISTURE READINGS HISTOGRAM
Roof Section 6

28	27	26	25	24	23	22	21	20	19	18	17	16	15	14	13	12	11	10	9	8	7	6	5	4	3	2	1	
A	6	7	8	8	7	9	8	8	9	7	7	9	7	7	9	8	10	7	16	11	18								8
B	5	7	7	8	8	7	7	7	8	7	7	8	10	9	6	7	8	16	22	22	25	17	9	9	10	12	11	13	
C																		17	24	18	20								8
D																		6	19	26	21	21	13	7	8	7	5	7	6
E																		7	15	24	27	21	7	7	8	8	7	6	
F																		7	24	29	23	18	7	8	9	7	6	6	
G																		6	8	21	24	24	16	8	8	9	9	8	
H																		8	7	8	9	11	8	7	9	9	10	11	7
I																													7
J																													8
K																													8
L																													5
M																													5
N																													6
O																													6
P																													7
Q																													7
R																													7
S																													6
T																													5
U																													7
V																													5
W																													7
